HIGHLAND PARK RESERVOIR DAM

MONROE COUNTY, NEW YORK

INVENTORY NO. N.Y. 790

PHASE I INSPECTION REPORT
NATIONAL DAM SAFETY PROGRAM
HIGHLAND PARK RESERVOIR DAM
N.Y. 790

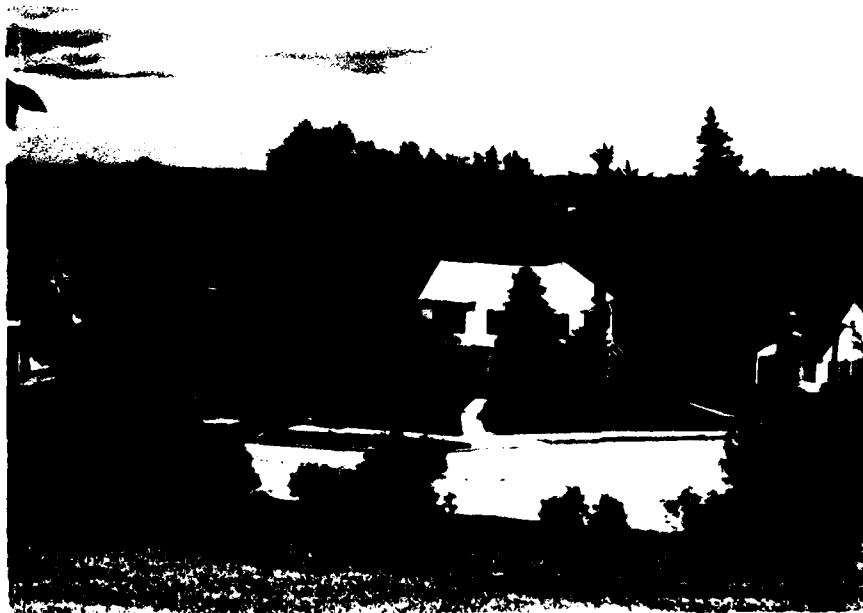
The dam is classified to be in the high hazard category. The reservoir is located within a heavily populated residential area of Rochester, New York.

It is estimated that failure of the dam under maximum pool level would cause loss of more than a few lives and appreciable property damage in this residential area.

PHOTOGRAPH NO. 6
Downstream Residential Area
(south of reservoir)

1. An emergency action plan should be developed, including a formal warning system to alert the downstream residents in the event of an emergency.
